ICE on the VIKING

Important Flying Tests : Results and Remedies : Resumption of Services

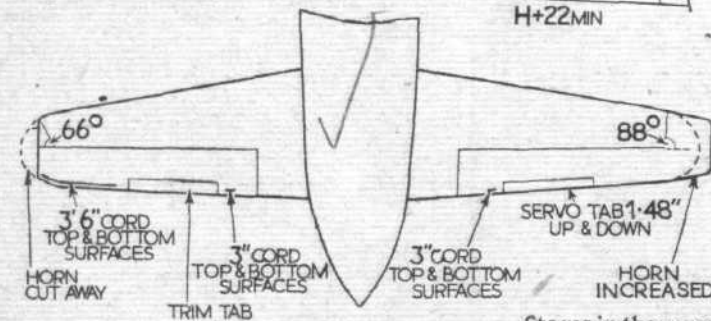
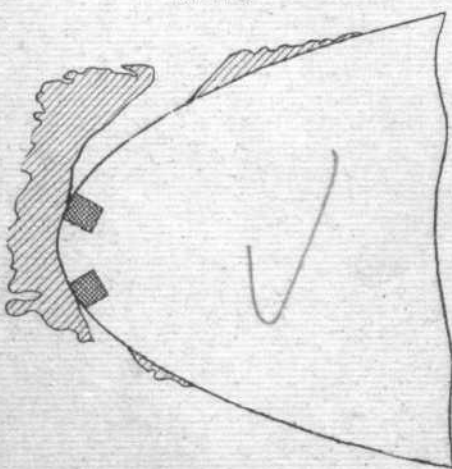
(Below) Elevator modifications. Quite distinct asymmetry results.

- (1) A reduction in size of port elevator horn to 62 per cent of the original. It is now shielded and is, in effect, only a mass balance.
- (2) Addition of 3ft 6in lengths of 3/8in tube above and below the trailing edges. (See diagram.)
- (3) Gearing-up of servo tabs to 1.5in each way instead of 1in.
- (4) Addition of a spring compensator (bungee) to give a 25 lb down-load at the controls.

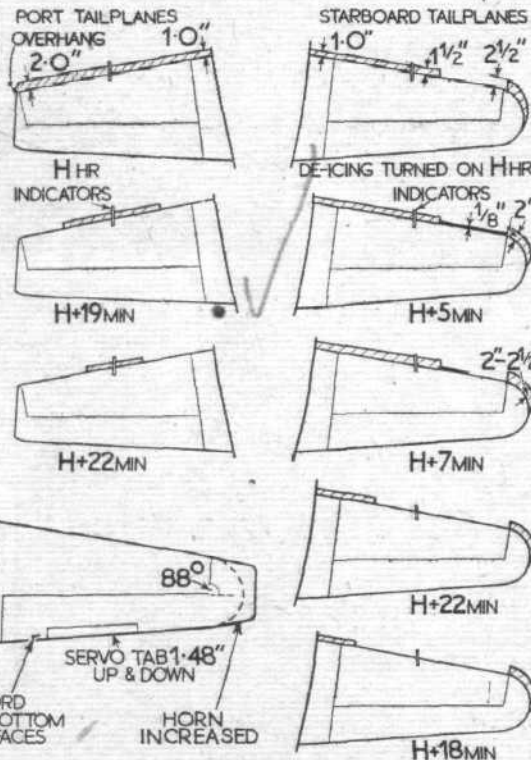
Possible effect of insufficient flow of de-icing fluid. The next stage may be a build-up of upper and lower ice sections to a three-pronged formation.

Stages in the removal of ice from tailplanes by the T.K.S. system with increased rates of flow.

- (a) An increased average flow over the whole aircraft.
- (b) Recalibration of delivery pumps to intensify local flow over tailplanes.
- (c) Addition of a second fluid pump as a standby and for emergency delivery increase.

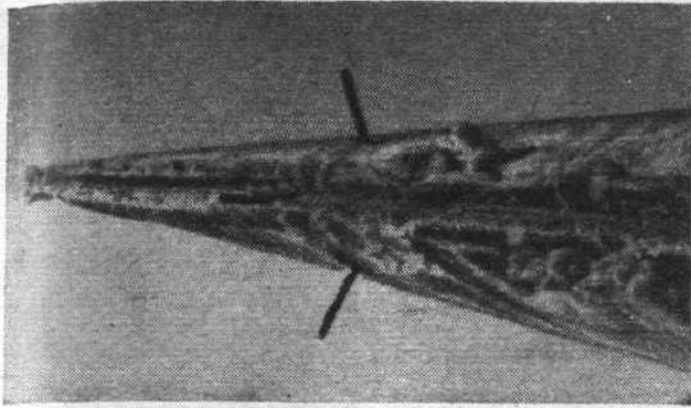
Ice on the leading edge of the starboard tailplane. The upper indicator is free but the horn balance is heavily coated.

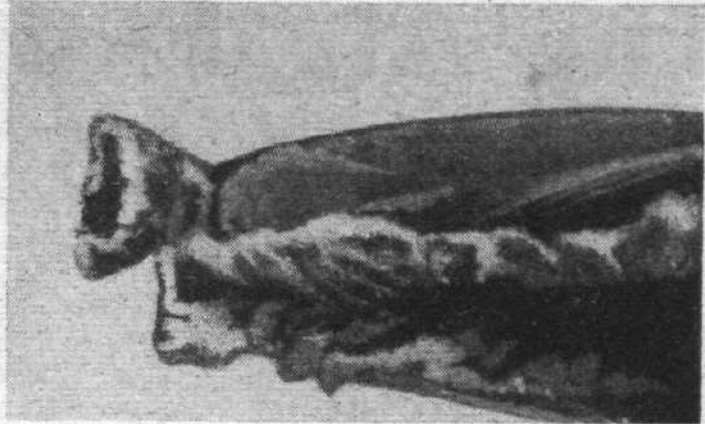
A large "cabbage" has formed on the starboard elevator horn.

The extraordinary cabbage formation on the elevator horn has been drawn in its various stages of formation. Being entirely stalled, the iced horn had no effect on the elevators except as a mass balance.

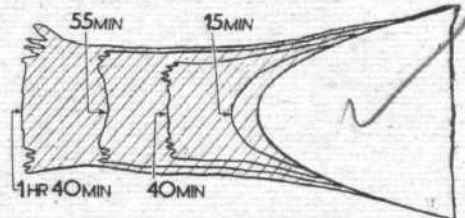
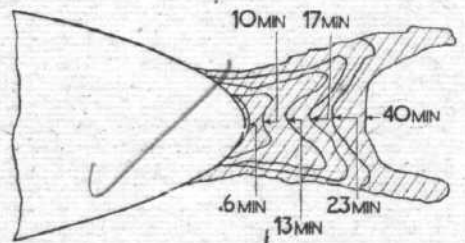
Stages and times for the build-up of ice formations on tailplane leading edges in medium icing conditions.

Most of the tests were conducted in normal icing conditions, and an average rate of build-up was one inch in 20 minutes, although on one occasion of severe icing one inch formed in 3 minutes.
